MONTANA
Department of Transportation

Memorandum

Subject: Guidance for Choosing and Detailing Bridge Expansion Joints to Increase Durability and Resiliency.

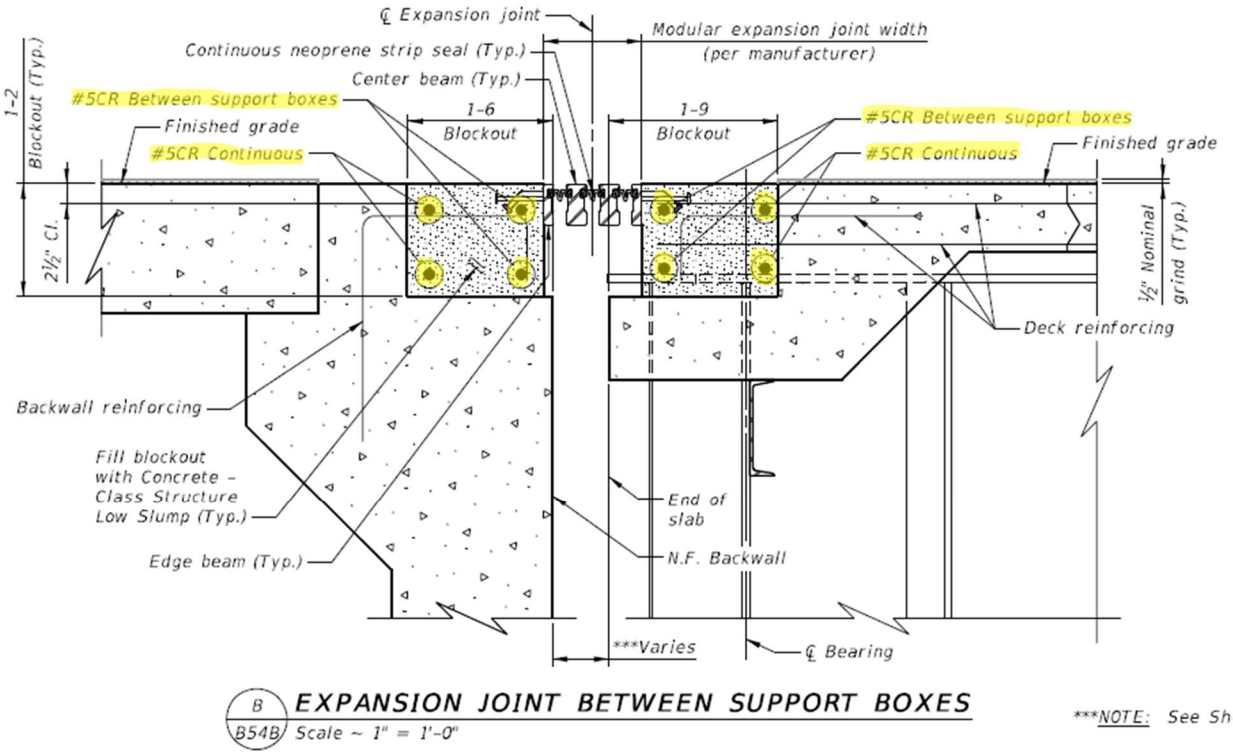
In most of the recent failures in “new” (1 to 5 years) joints and even many of the older joints that have failed in the past, a common condition is often observed. That condition is the lack of transverse or longitudinal reinforcement near the joint or the joint concrete anchors. When there is misplaced or inadequate reinforcement in this area, and if the concrete deteriorates or if it was not consolidated properly under the joint header, there is little to prevent the entire joint from quickly getting loose, potentially cracking the steel, and presenting a safety hazard to traffic, along with causing an unnecessary strain on Maintenance resources.

This lack of reinforcement may sometimes result from the normal process of installing transverse deck rebar at specified intervals and longitudinal rebar at specified laps. If installation is started at one end of a bridge deck and works to the other end where a joint is located, an error of fractions of an inch of each transverse spacing or lap can result in a reinforcement void at the far end of the deck at the joint. Regardless of the cause, an unreinforced anchorage zone of the joint header is not an uncommon condition.

Getting rebar into this section of the deck near the joint is important for the durability of the joint header in the long run. However, it is also critical in the short run if there is some issue with the deck concrete or it is not consolidated properly under the joint header. This properly placed rebar will not prevent a failure when concrete is not consolidated properly during construction, but it will add some resiliency and likely give more of a “ductile” type failure where the joint gives some audible warning and slows the ”unzipping” failure effect of the entire joint. This gives Maintenance time to find and repair the joint before it becomes an urgent safety issue.

- Avoid unreinforced areas of concrete above the joint assembly concrete anchors. Add additional joint specific transverse reinforcement separate and in addition to the existing deck reinforcement where necessary.

- Call out the specific locations (i.e., attached to top of concrete anchors) or maximum edge or joint element clearances to ensure that the additional rebar is placed properly.

- Call out maximum clearances of the longitudinal deck reinforcement to ensure that it extends into the joint anchorage influence zone, where applicable.

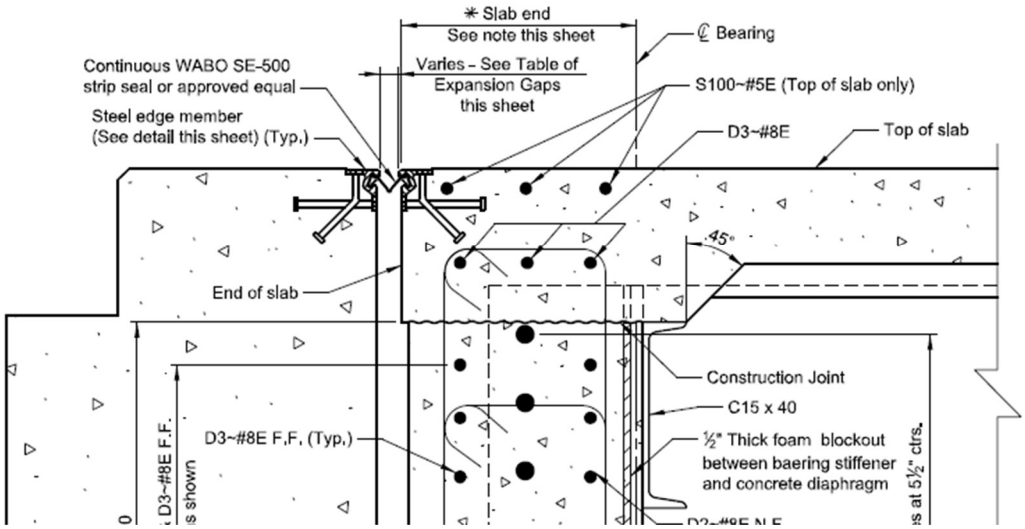
Modular Joint Headers:

Good Example of Labeling and calling out all specific bar sizes and locations in the joint closure pours.

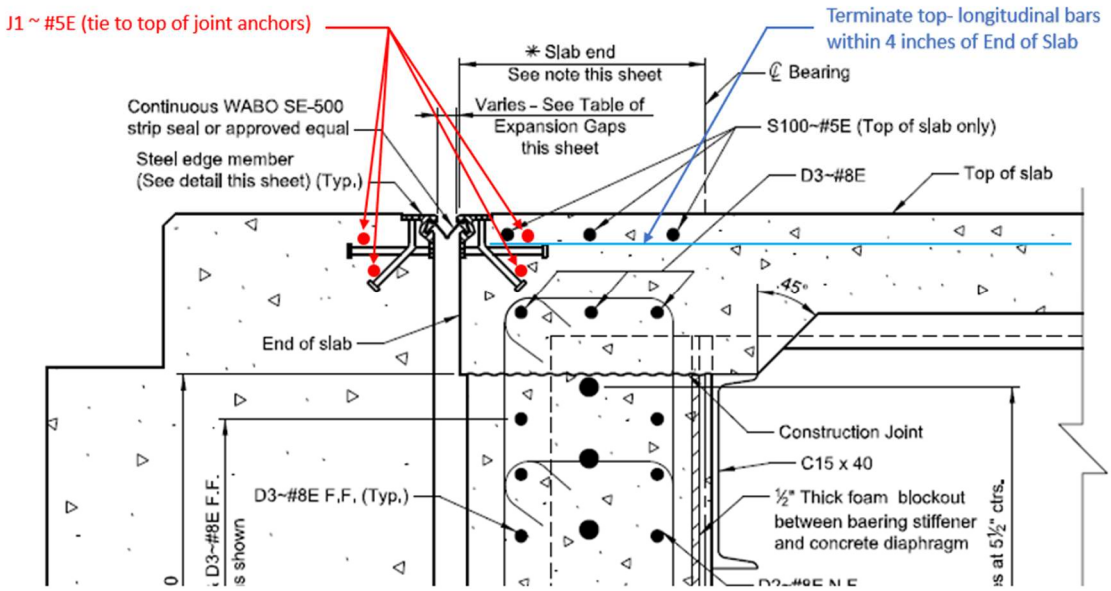
Strip Seal Joint Headers:

Typical Strip Seal Joint Detail without reinforcement.

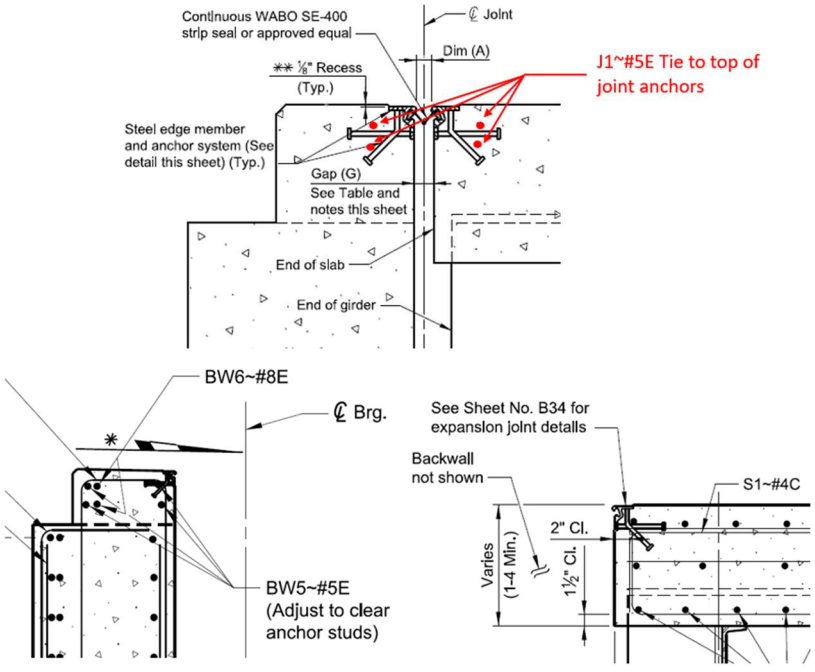
Series of Joint and Reinforcement Details for a Single Strip Seal Joint. Longitudinal Reinforcement is Adequate; However, Additional Joint Specific Transverse Reinforcement is Needed.

Suggested Additional Joint Specific Transverse Reinforcement.

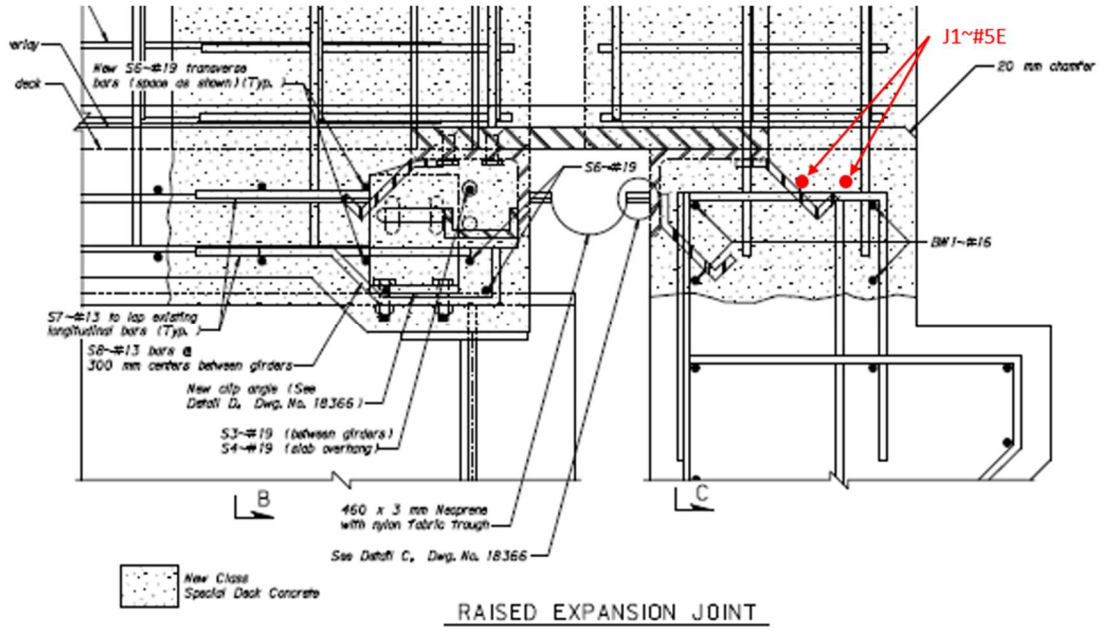
Joint Assemblies (Finger and Plate Joints):

No Transverse Reinforcing in Abutment Side of the Finger Joint above the Concrete Anchors.
